# California Department of Forestry and Fire Protection

## INVESTIGATION REPORT

**NAME:** Rice Fire

**CASE NO.** 07-CDF-572

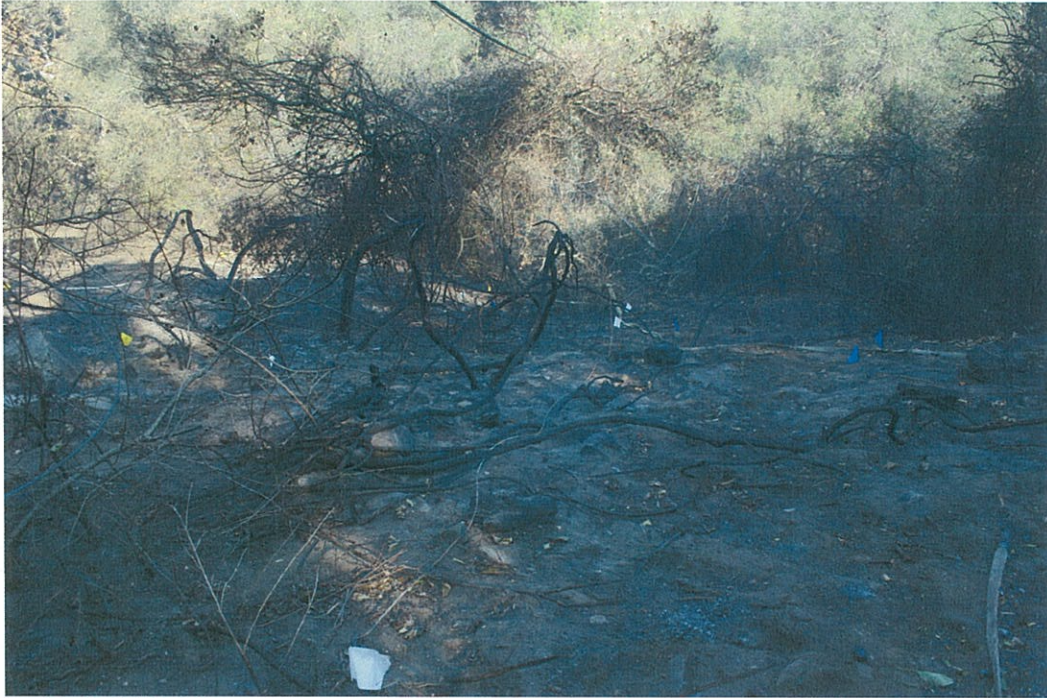
P-37 MG View of backing fire, with power lines marked with white flags

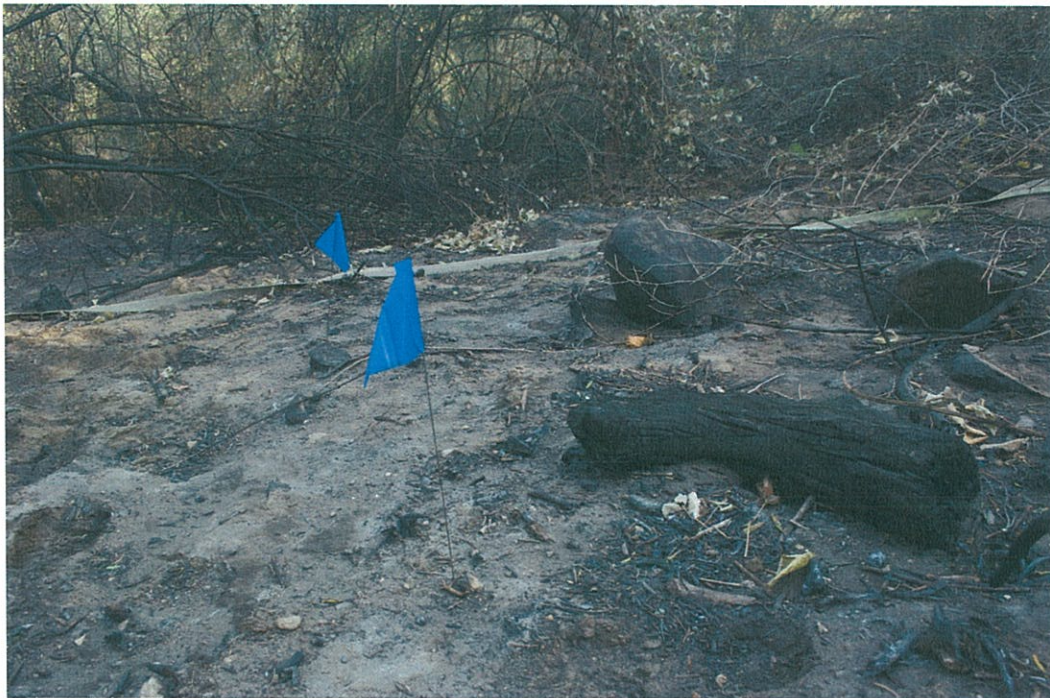
P-38 MG Overall view of backing indicators

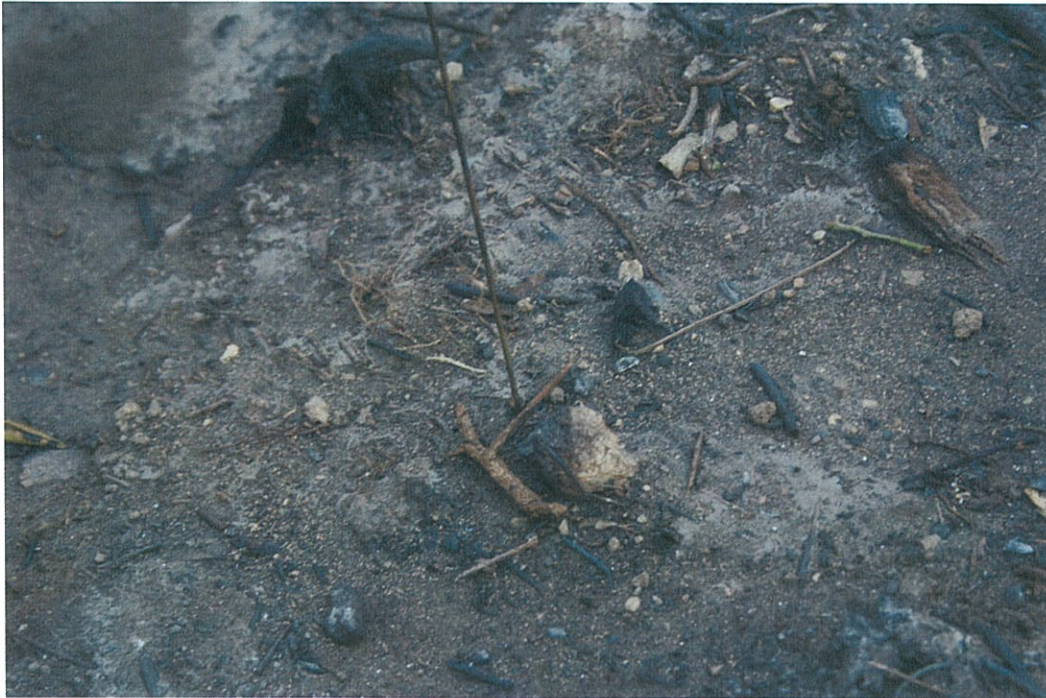
P-39 MG View of damage differential, showing backing fire

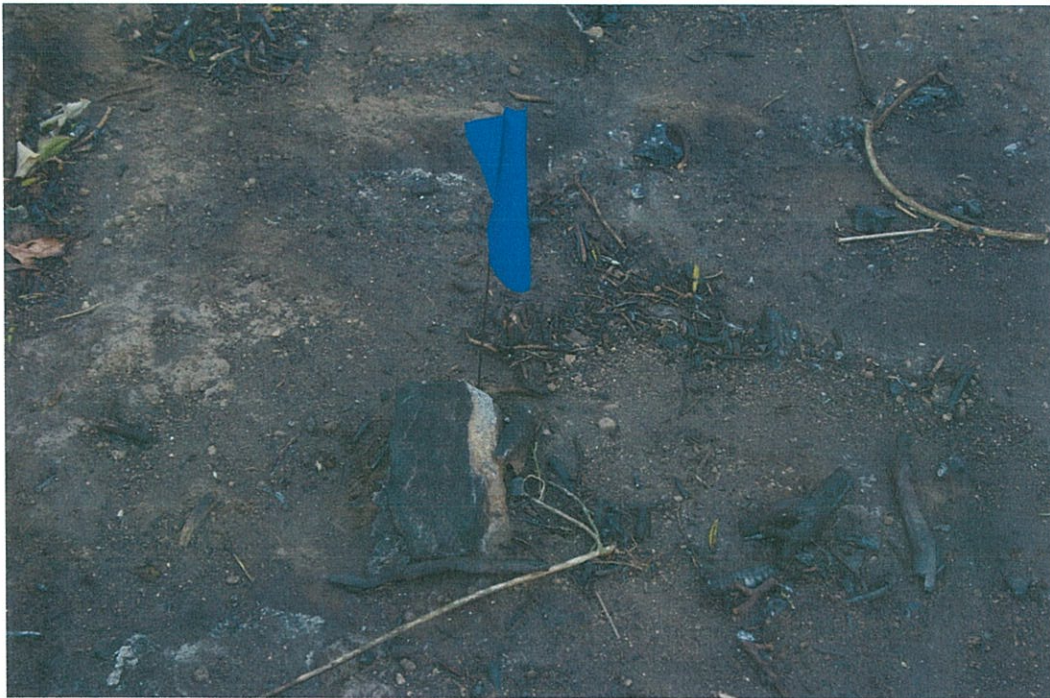
P-40 MG View of damage differential, showing backing fire

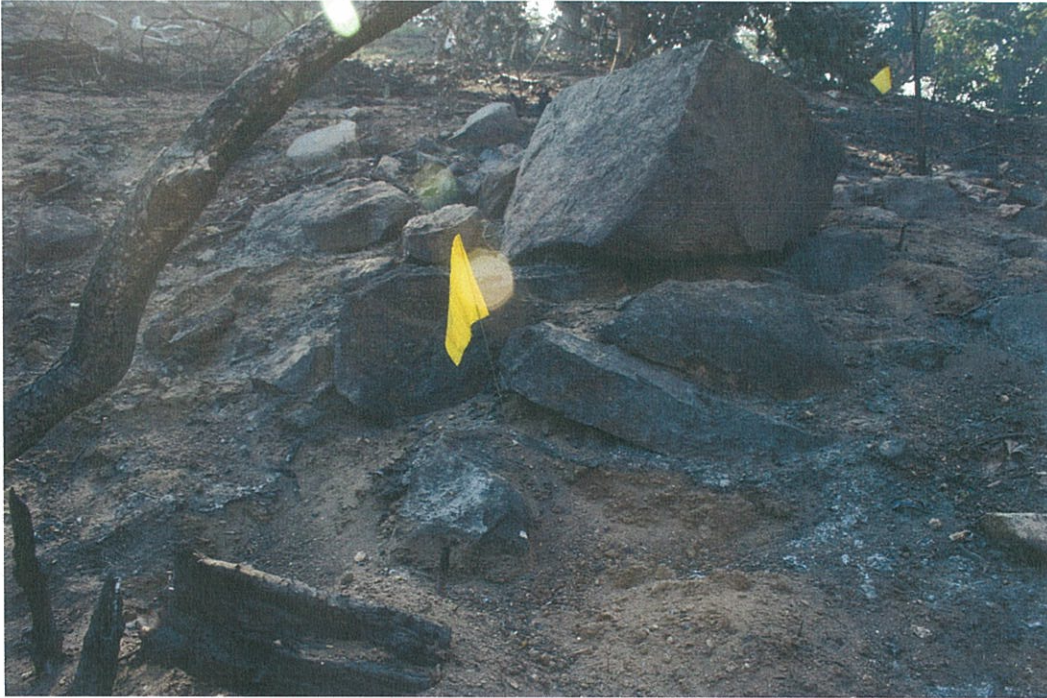
P-41 MG View of damage differential, showing lateral fire

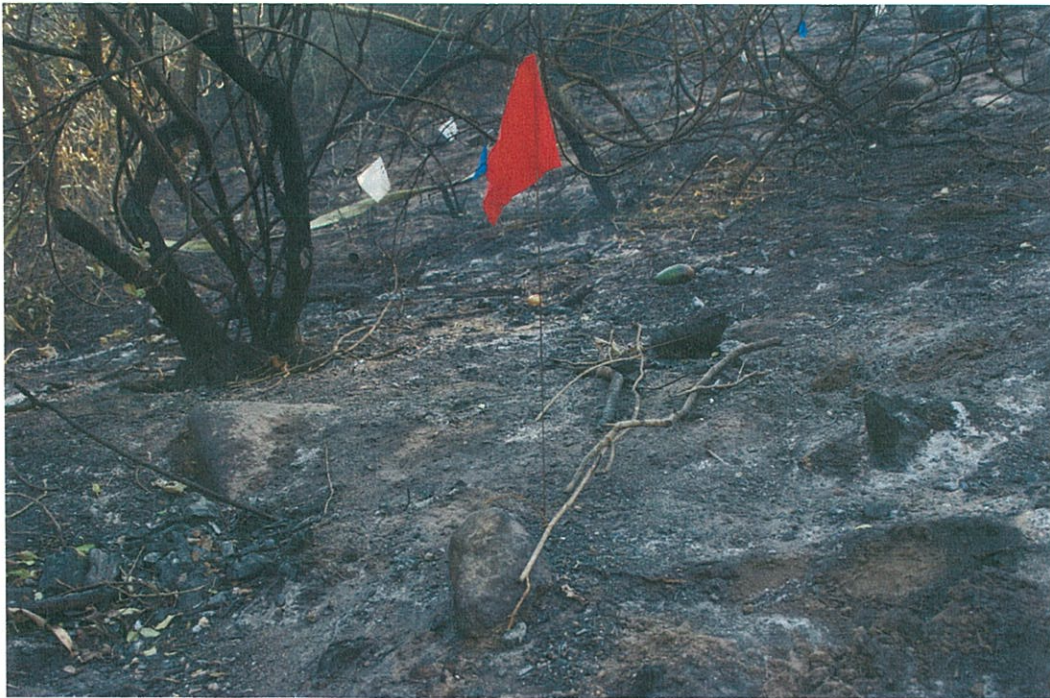
P-42 MG View of advancing fire from SOA, protected side

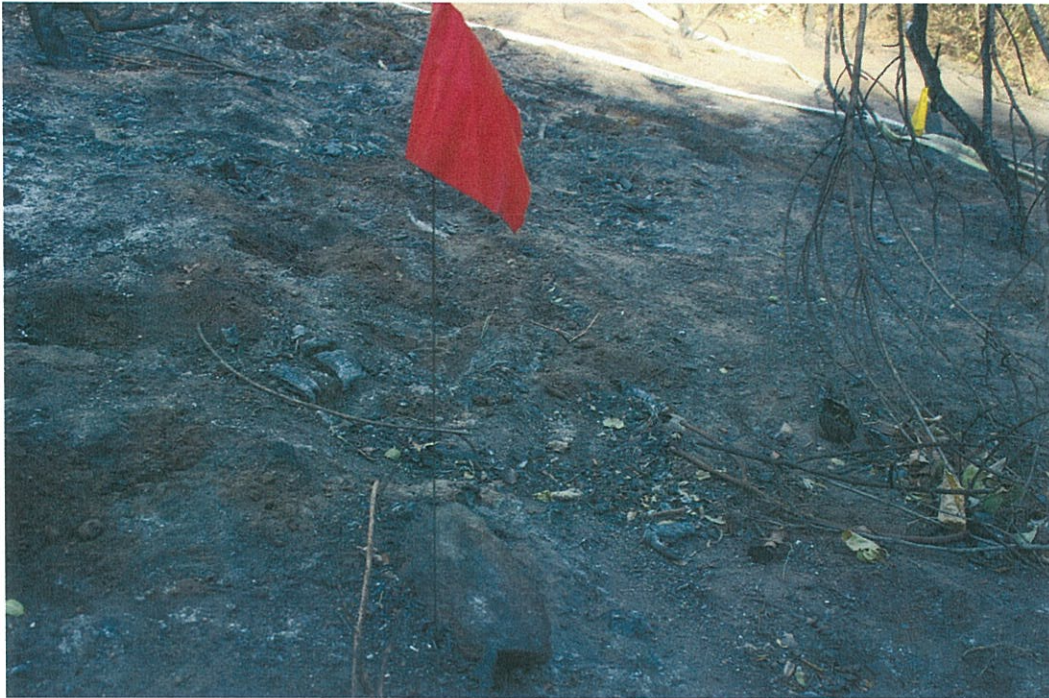
P-43 MG View of exposed side

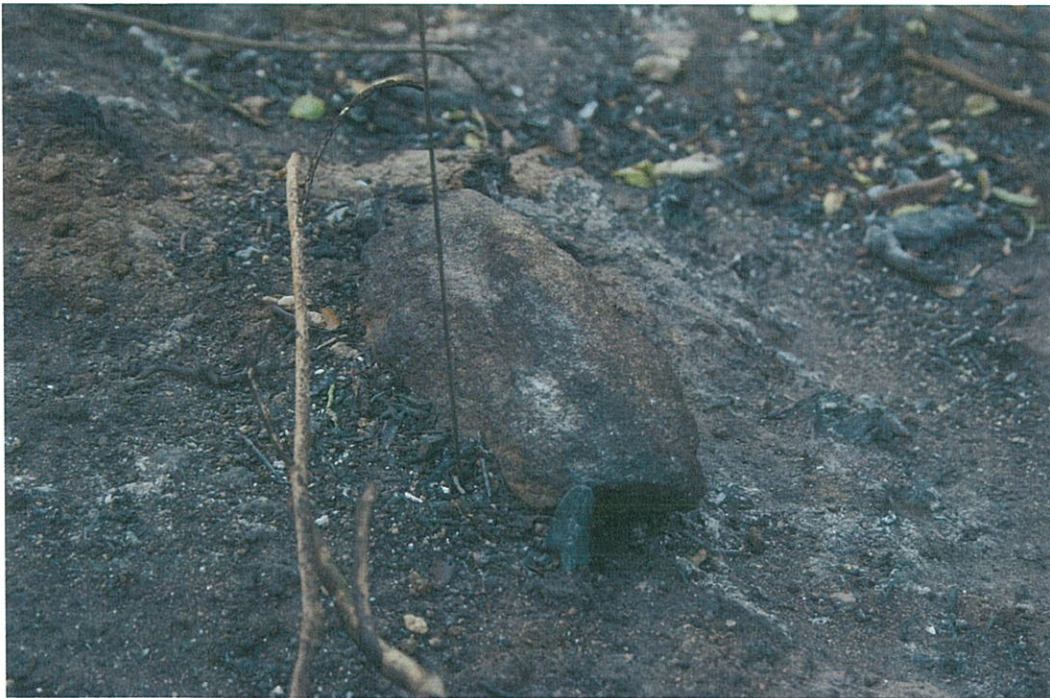
P-44 MG Close-up view of exposed side

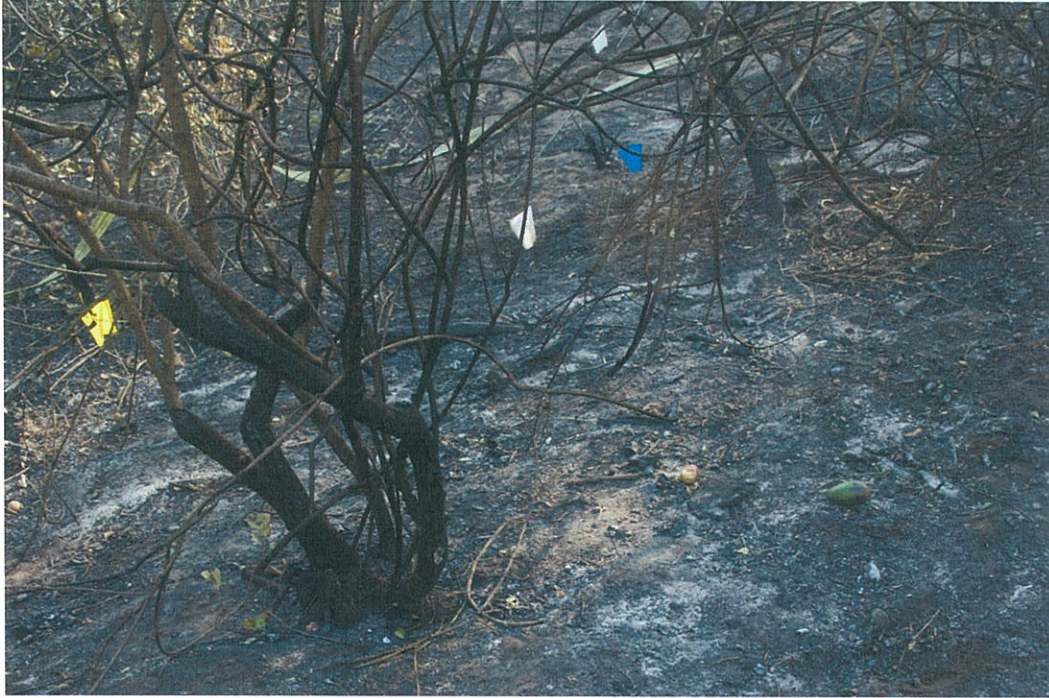
P-45 MG View of SOA

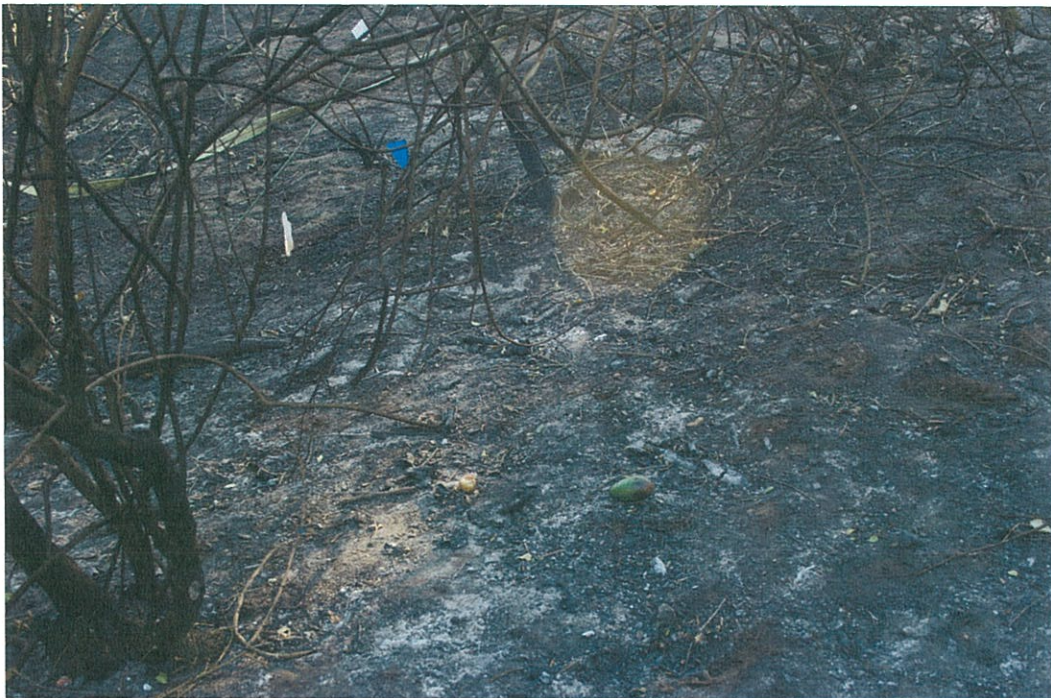
P-46 MG View of SOA

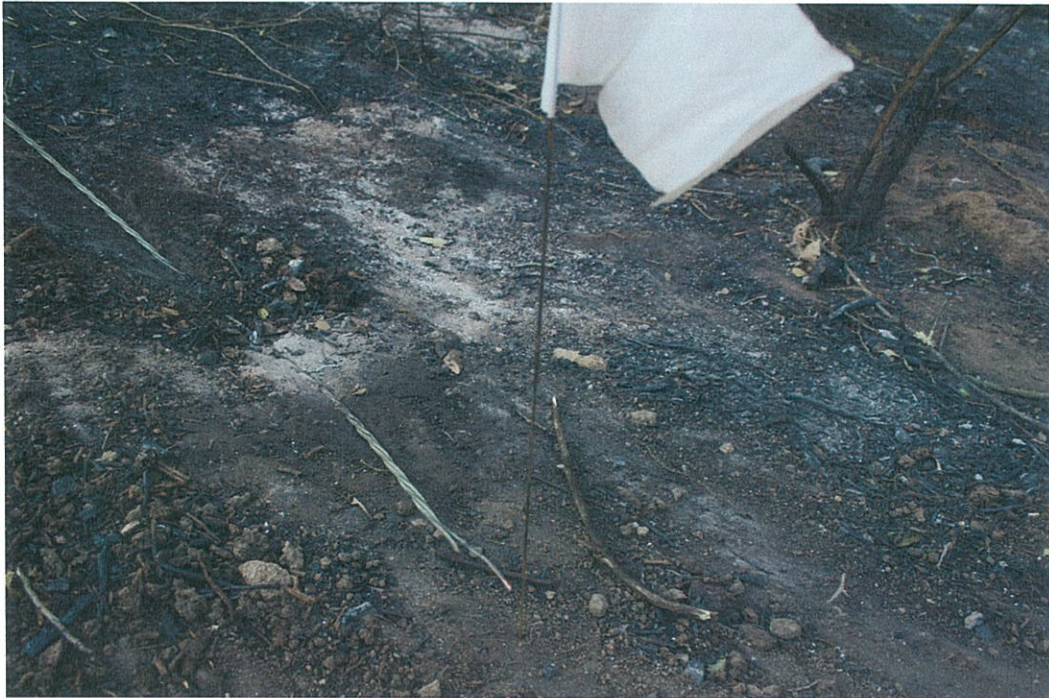
21 Power lines – During my investigation of Specific Origin Areas #1 and #2 I located  
22 downed power lines. Each line showed areas of spackling and arcing. Witness  
23 statements place the fire as being small in size near the areas I identified as the  
24 Specific Origin Areas and the power going out between 4:00 and 4:15 AM, which  
25 correlates to the estimate provided by SDG&E. During the course of the  
26 investigation I eliminated all other causes for the fire, determining the Rice Fire to  
27 be a power line caused fire.

P-47 MG View of power line

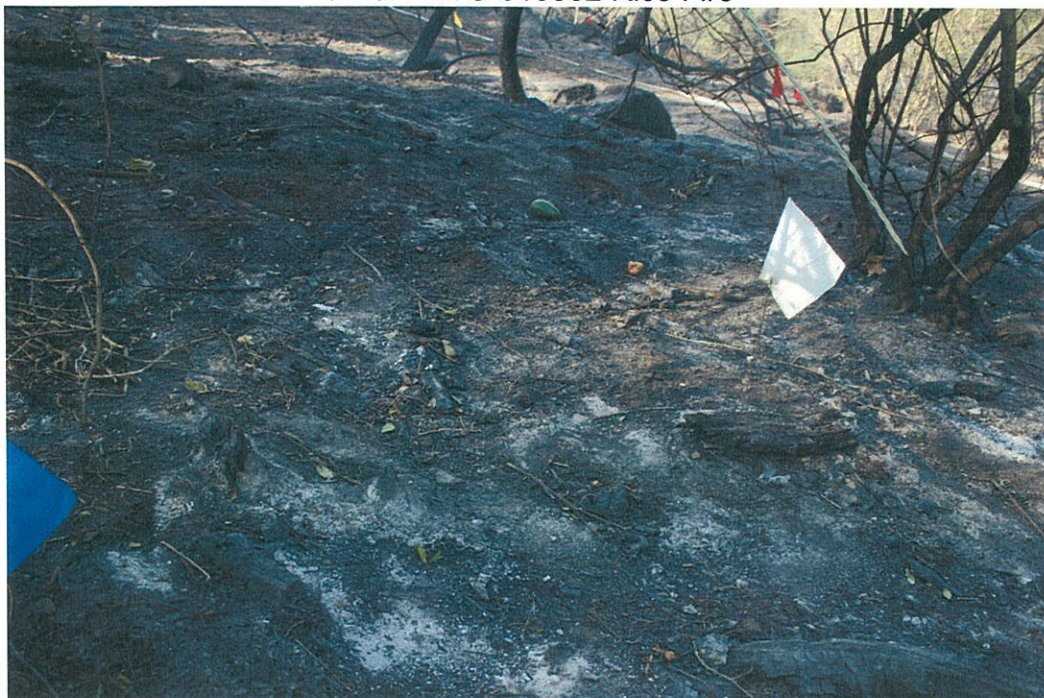
P-48 MG View of power line

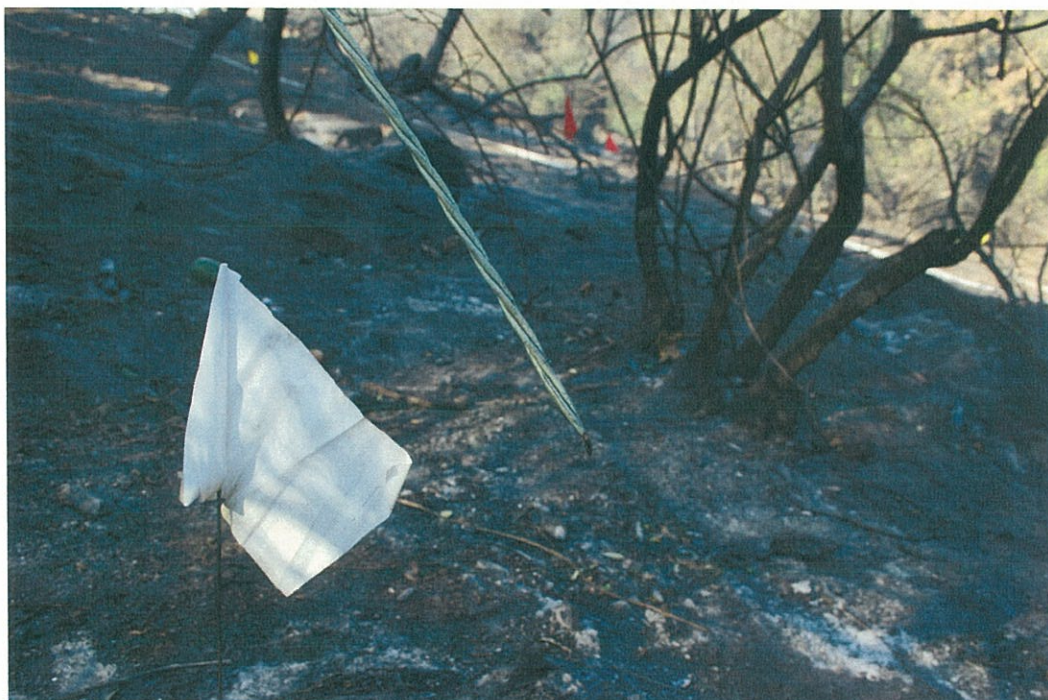
P-49 MG View of SOA with power line

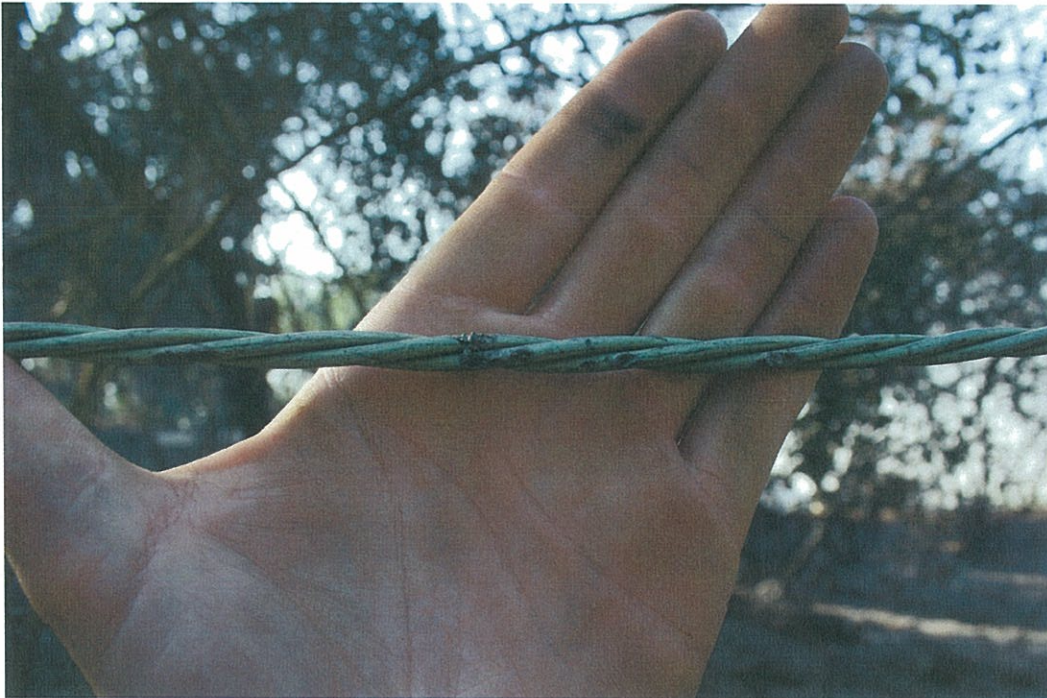
P-50 MG Close-up view of power line

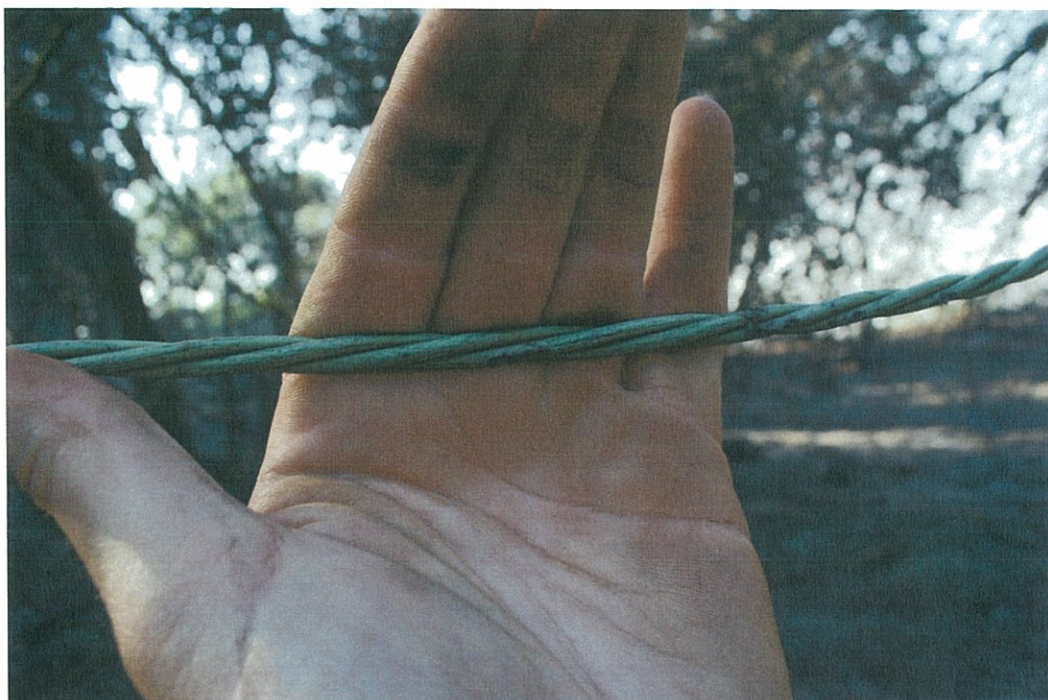
P-53 MG View of arcing and damage to power line

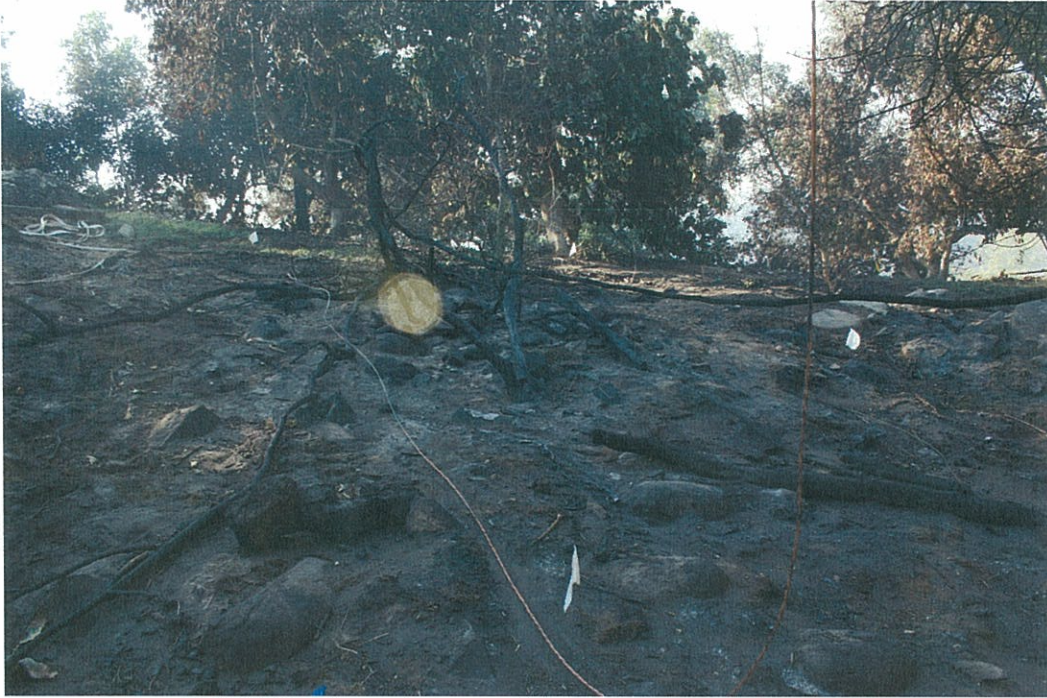
P-54 MG View of power line

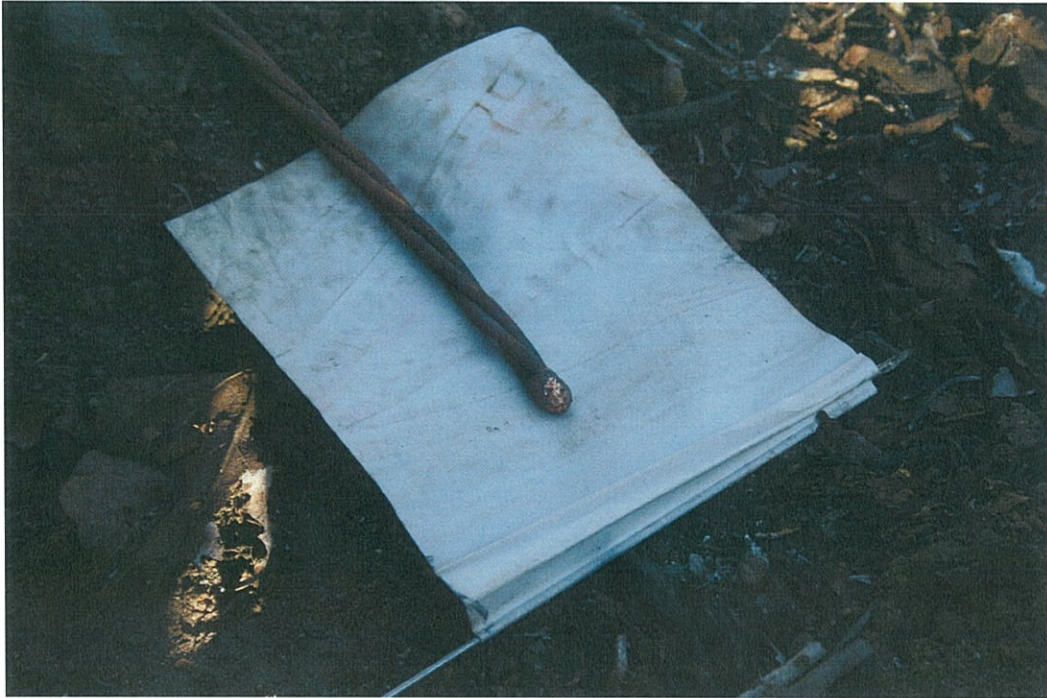
P-60 MG Close-up view of beading

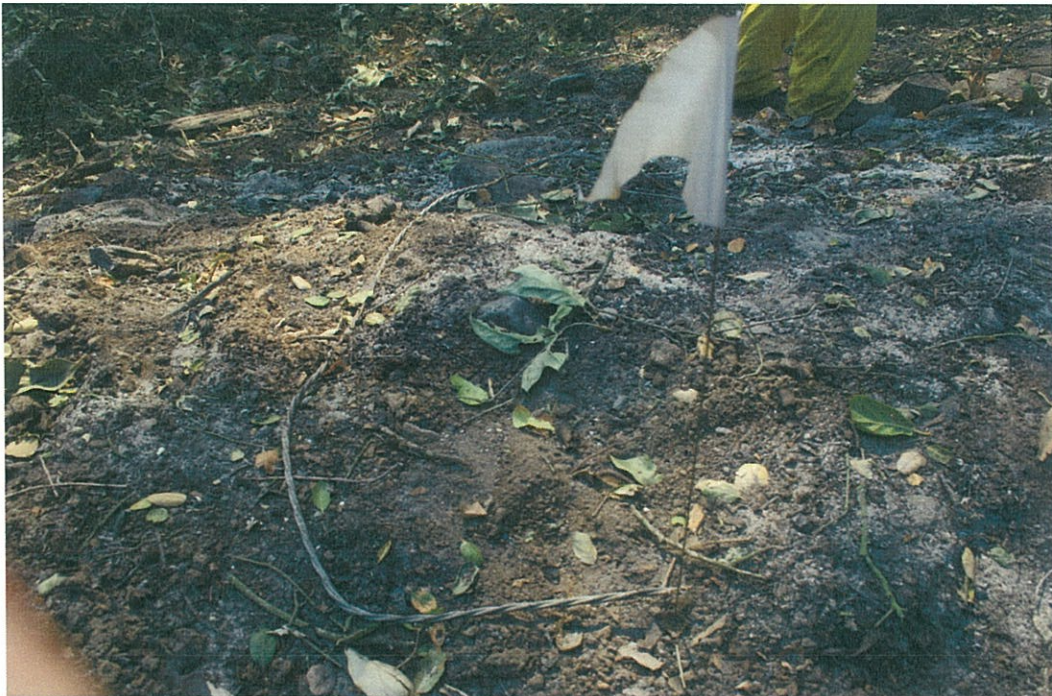
P-84 MG View of downed power lines

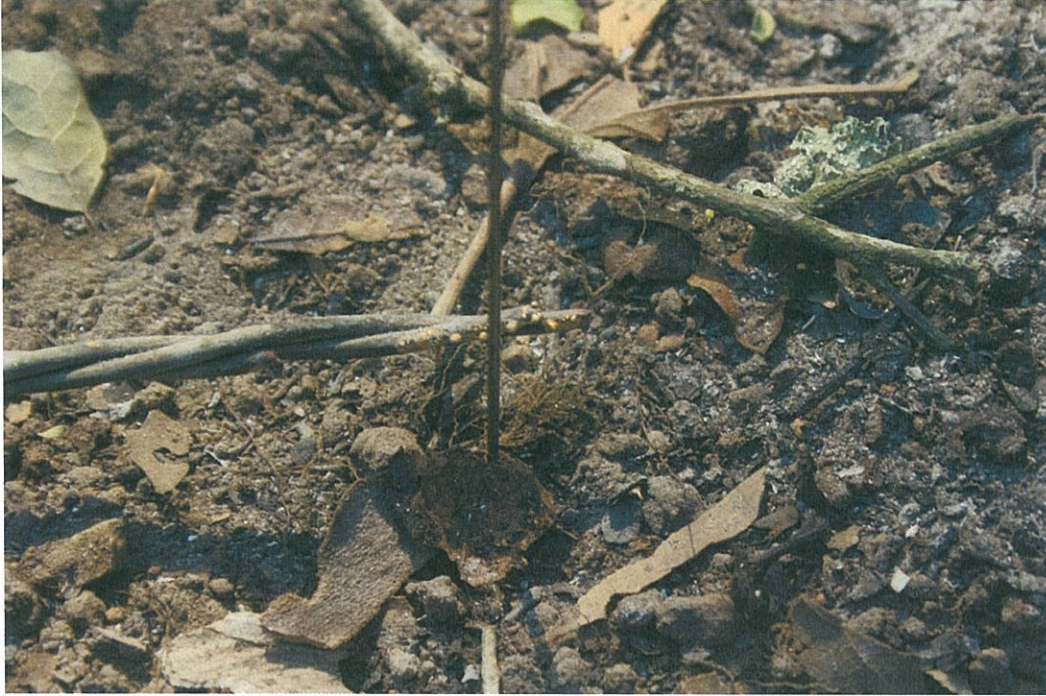
P-85 MG View of downed power line, in SOA

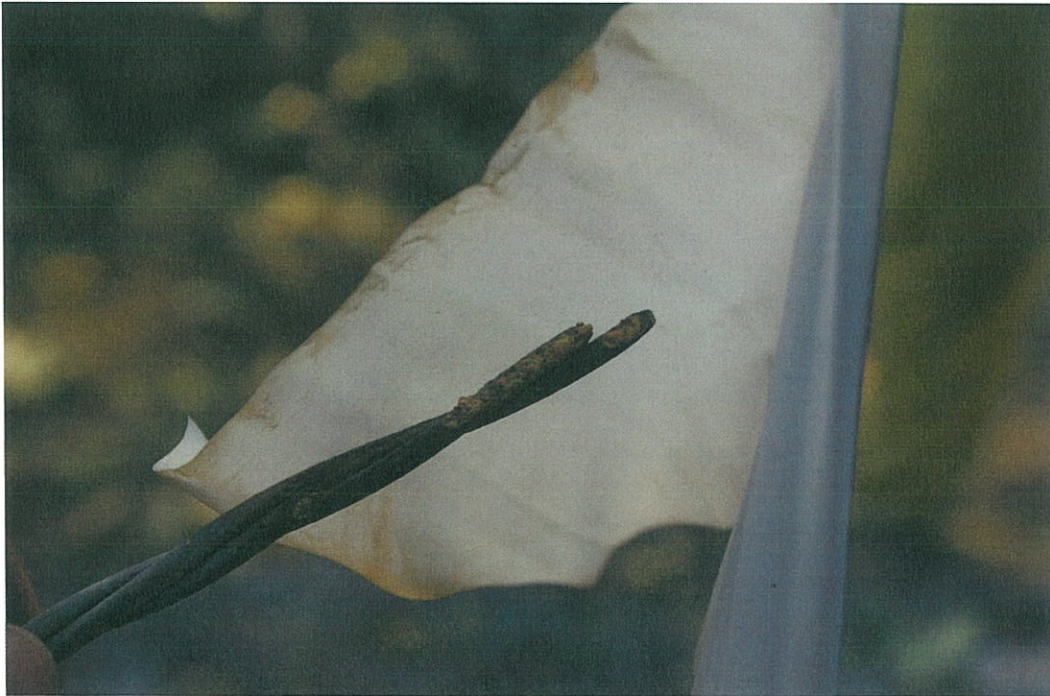
P-86 MG Overall view of downed power line

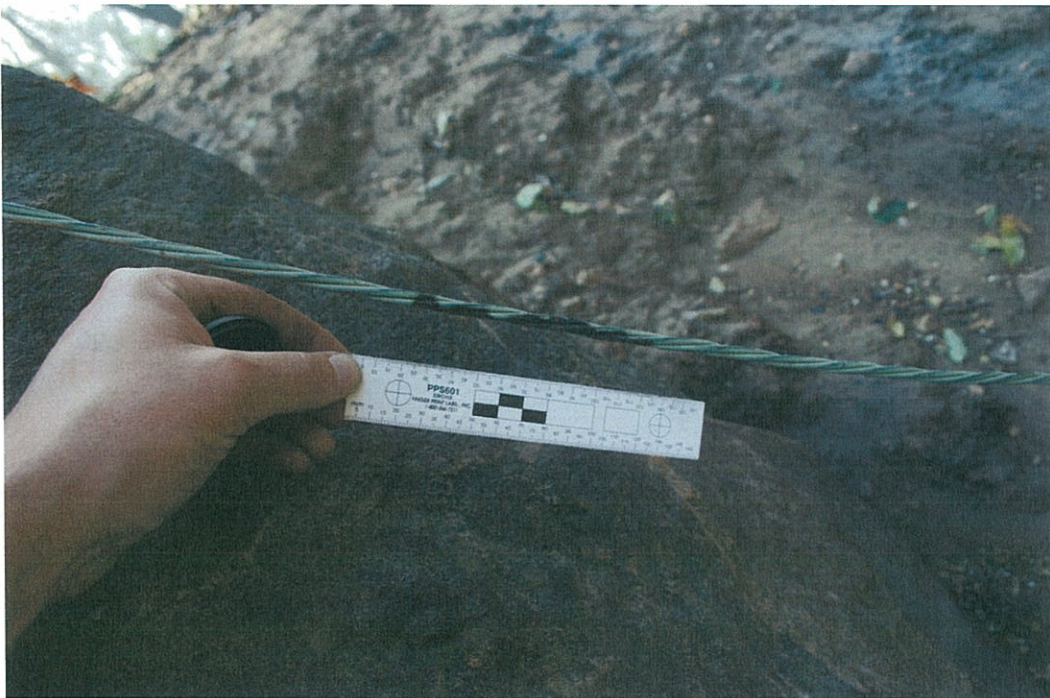
P-88 MG Close-up view of arcing on power line

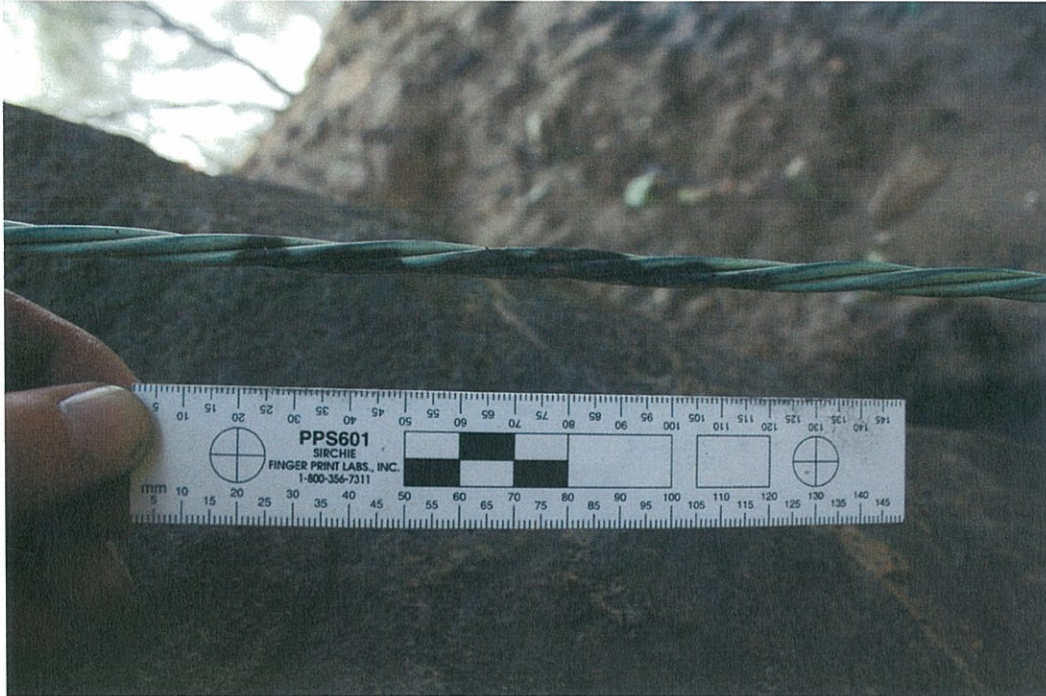
P-89 MG View of power line hanging on west side of Rice Canyon Road

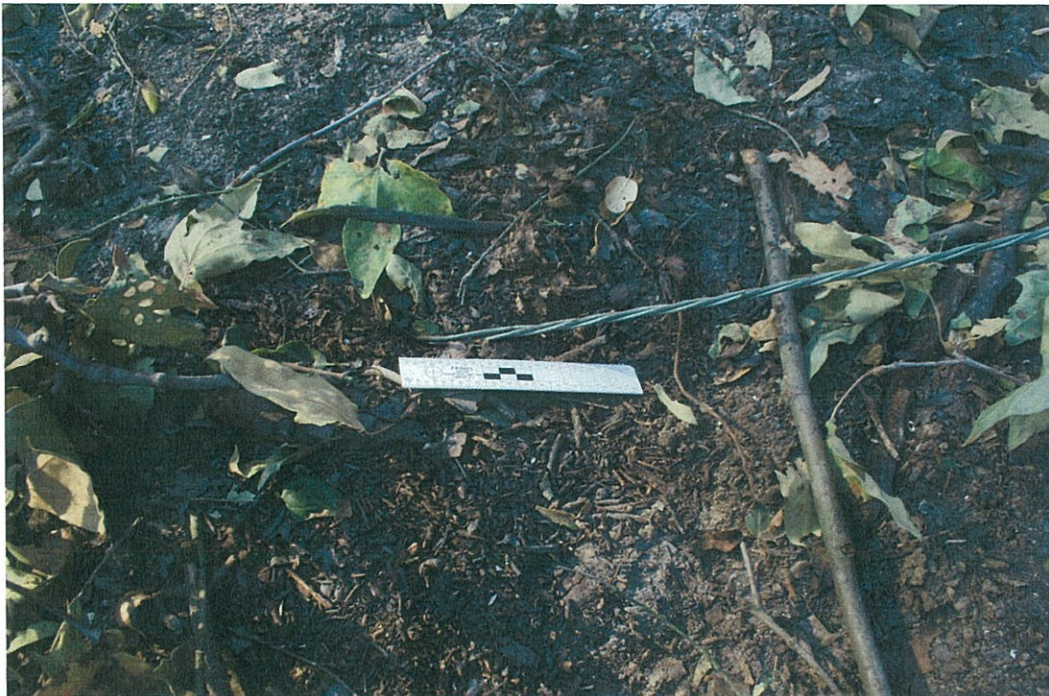
P-90 MG Close-up view of arcing on power line

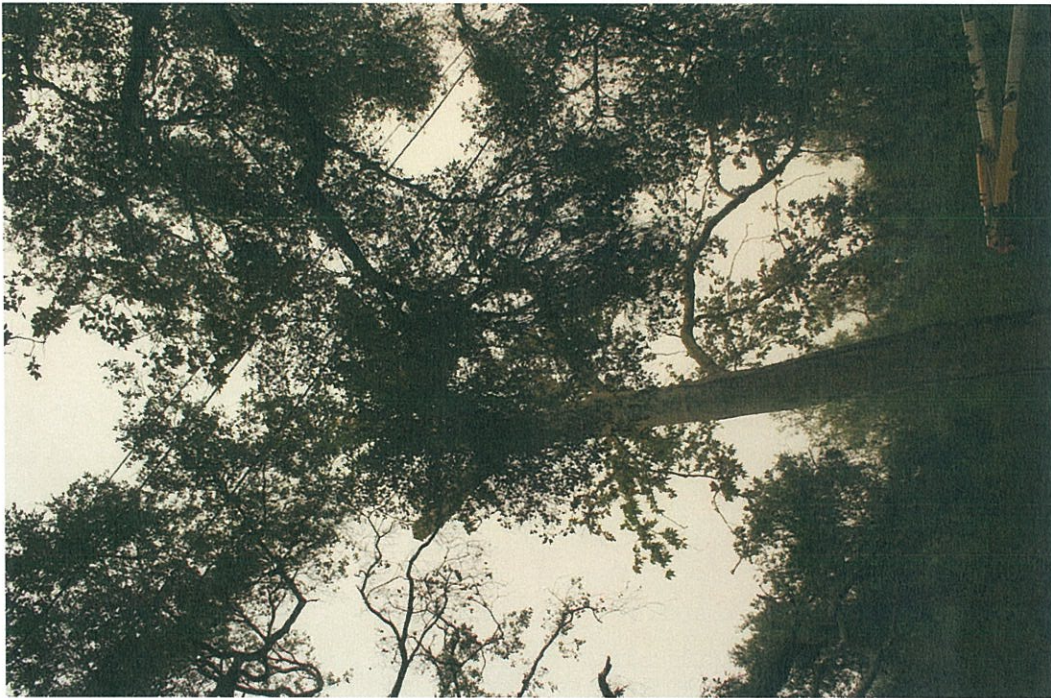
P-3 MG View of area where lines traveled through trees

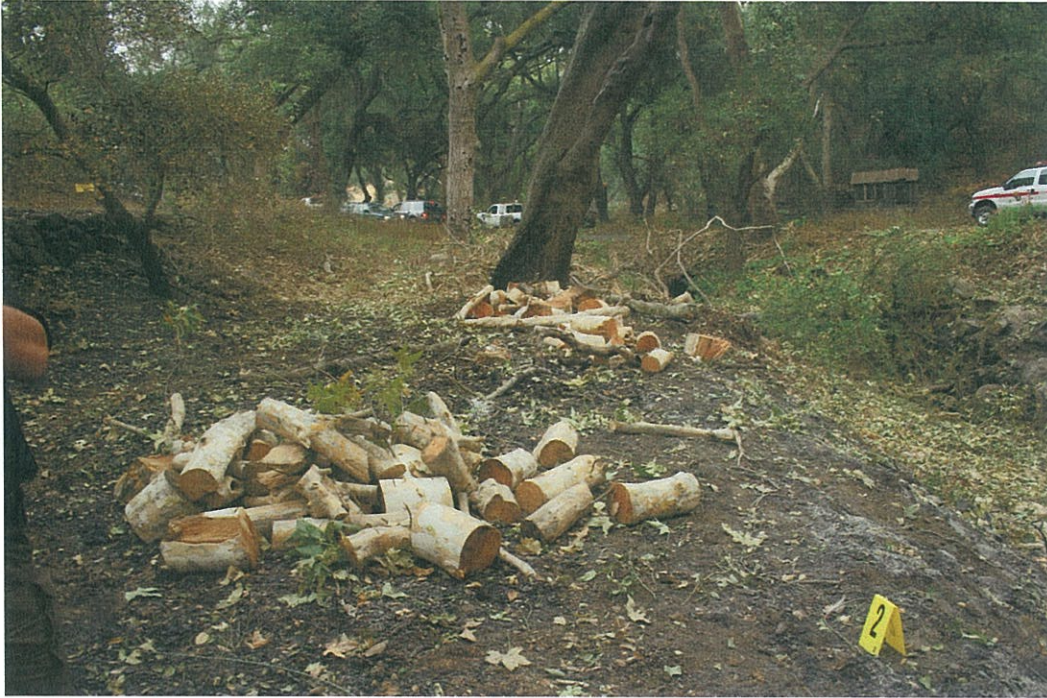
P-4 MG View of work done to sycamore tree
